COPAKE FURNACE

Copake, New York

CONDITIONS ASSESSMENT / RECOMMENDATIONS

January 24, 2005

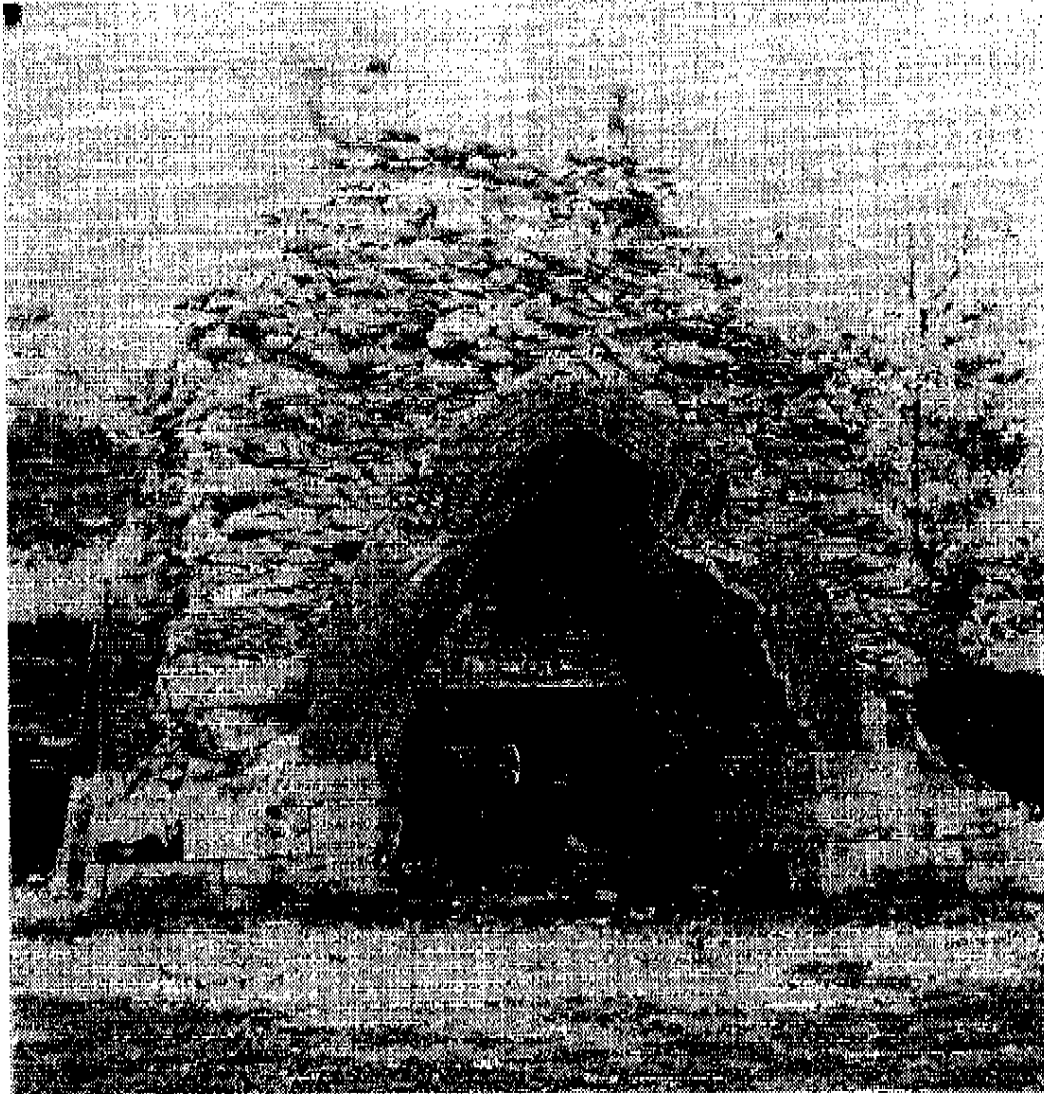
as it appeared shortly after the face stones were removed (illustrations 1 and 2). All face stones were removed except for the lower three courses at the arch bases and two base courses elsewhere. The corners of the stack were retained which enables perception of the dimensions of the furnace at its base. The remaining mass of back-up rubble above the courses of face stone are quite irregular and significantly smaller at the top. The rubble appears to taper slightly to the two-thirds height and then drastically steps inward in the top third. There were no fallen stones at the base of the furnace in the circa 1935 photographs.

Illustration 1: View of casting arch (north side) of furnace, circa 1935
(Photograph provided by Mr. Raymond Doherty, New York State Office of Parks, Recreation and
Historic Preservation. The original source is unknown and the date is assumed.)

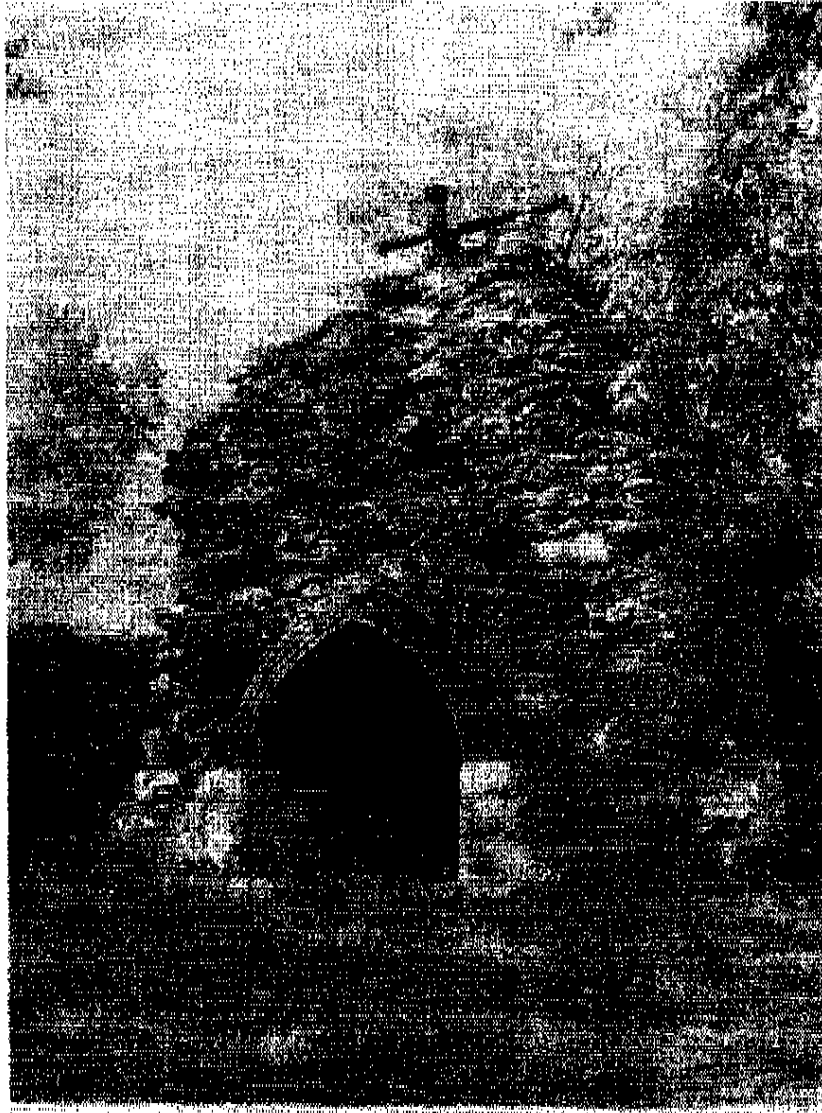
In the late 1920s or early 1930s, when Copake's face stones were removed, the brick casting arch was in very good condition. The finished face of the brick arch was intact, and it extended beyond the back-up rubble to the depth of the former face stones. But as early as 1935, the forewalls at the inside end of the casting arch had begun to deteriorate, and a large area of missing brick can be seen in a c. 1935 photograph of the hearth area (illustration 6). In 1935, the casting arch had two large areas of removed brick and some loss of brickwork in the lower course at the west side (illustration 1), but the east tuyere arch was in perfect condition (illustration 2). The condition of the east and north brick tuyere arches in 1935 is unknown.

Illustration 2: East side of furnace, circa 1935.

The east tuyere arch is in perfect condition

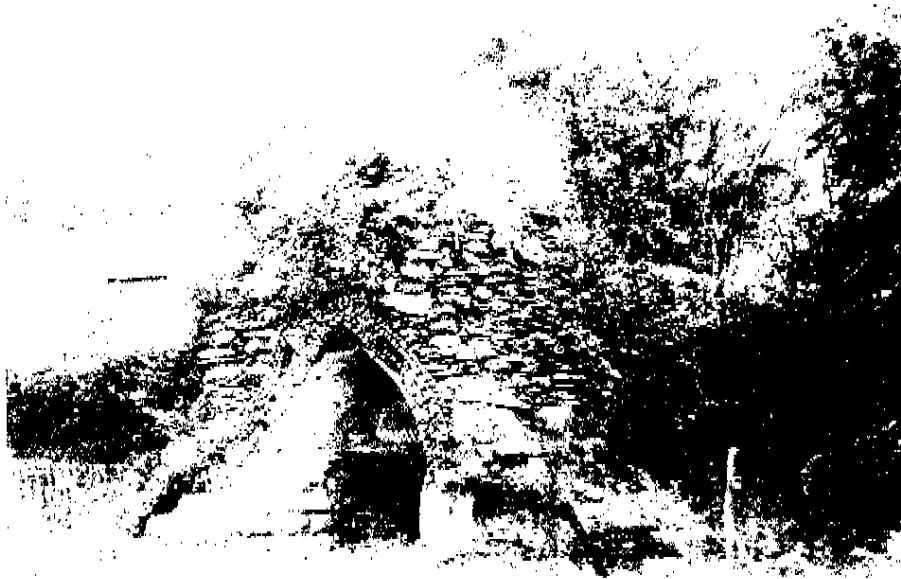
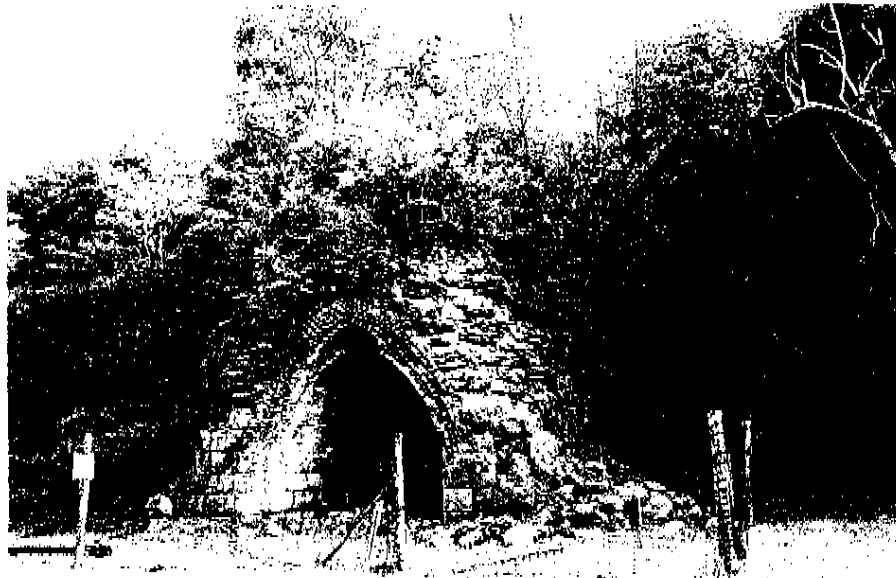
The stack was photographed in 1973 by Victor Rolando (illustrations 3, 4 and 5). A comparison of the circa 1935 photographs to the 1973 photographs shows a minor amount of additional stone loss, excessive plant growth on the back-up rubble, and a relatively small amount of fallen stonework at the furnace base. The brick lined casting and tuyere arches (see arches below) experienced the greatest amount of deterioration. The site was kept somewhat tidy as a pile of bricks can be seen in the foreground in some of the photographs in front of the casting arch.

- *Casting arch:* The casting arch has experienced the greatest amount of brick loss of all of the arches. No finished edge remains except for a small section at the northeast corner. There are sections of the arch which have eroded beyond the depth of the back-up rubble. Many of the remaining bricks at the outside face are unstable. A number of loose bricks were noted at the apex of this arch. The fore- and in-walls at the back of this arch are substantially deteriorated. This deterioration has created an instability at the back of the arch.

**Illustration 3: Similar views from 1973 (above) and 2004 (below)
Casting arch side**

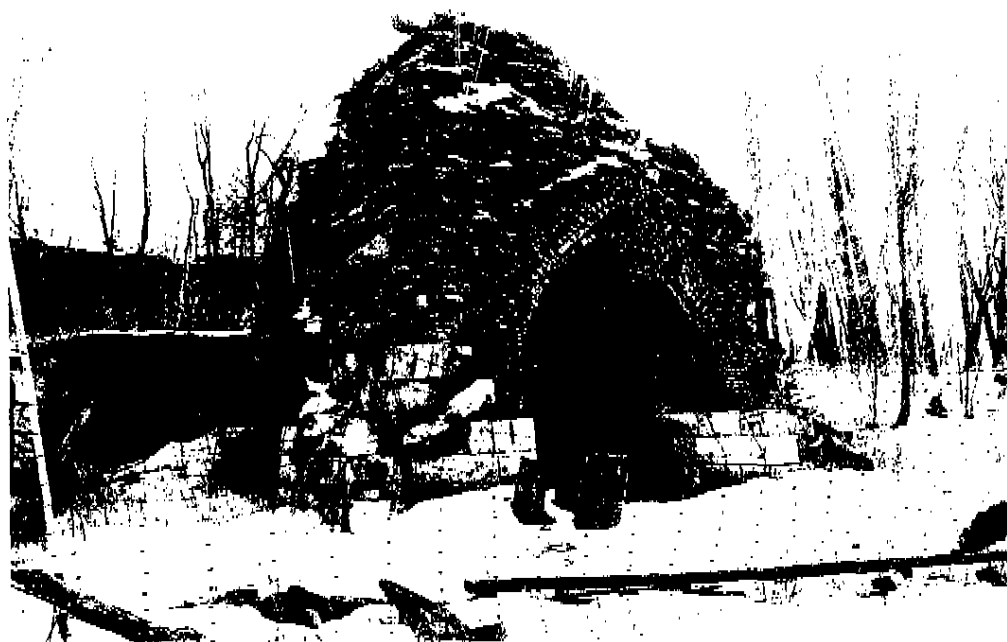
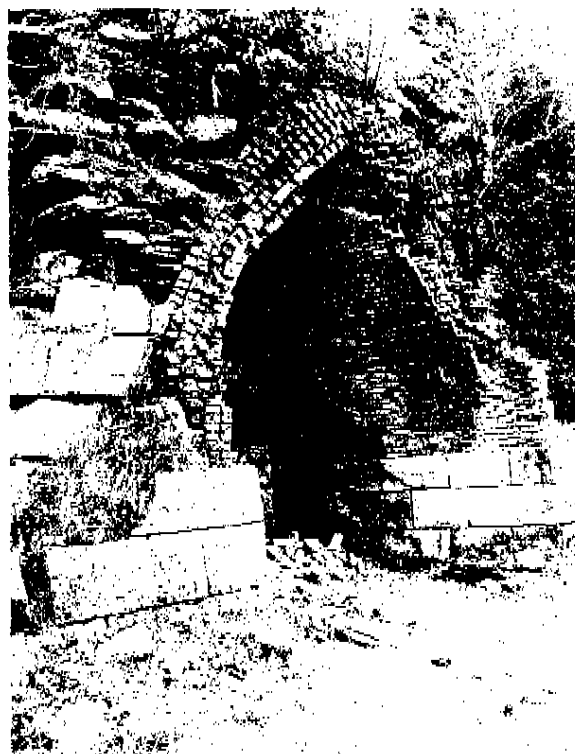
Illustration 4:
Casting arch side of furnace,
c 1973 (above), 2004 (below)

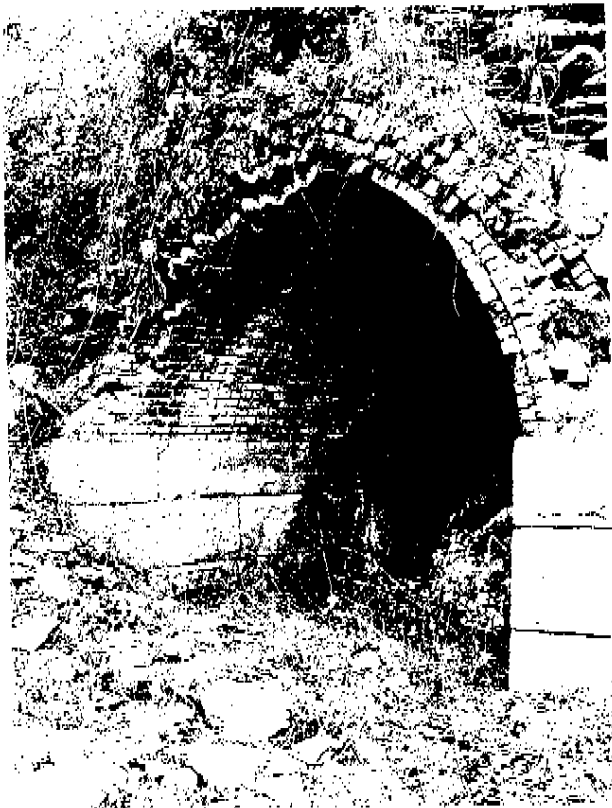
- *East tuyere arch:* The east tuyere arch has fared better than the other arches. The arch is missing to a depth of several bricks behind the finished course but still stands beyond the stack suggesting that its ability to support the back-up rubble has not been compromised. This arch exhibits the same failures as the south tuyere arch but is in a less advanced state of deterioration. Two courses of liner with finished edge remain at the lower part of the

south corner. The bricks surrounding the hot blast pipe appear to be stable. The remaining unfinished edge bricks are somewhat loose and unstable. Two bricks of the first layer are missing.

**Illustration 5:
East tuyere arch,
c 1973 (above), 2004 (below)**

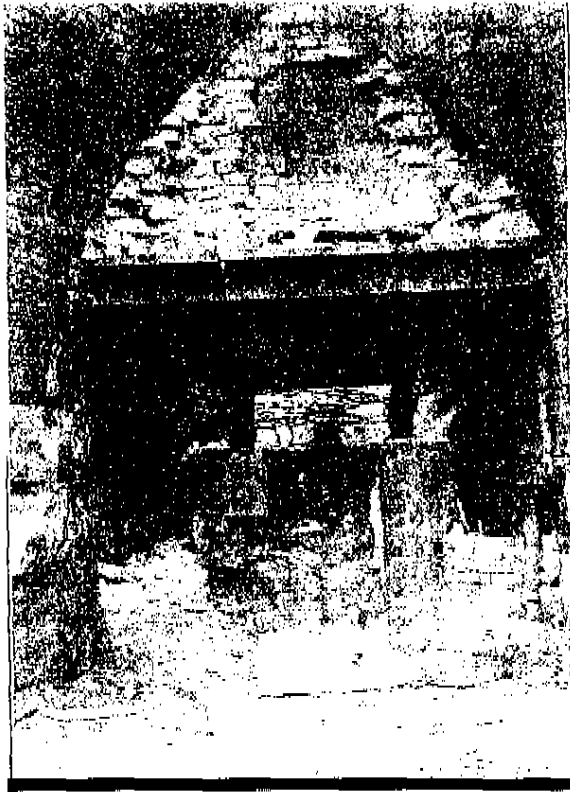
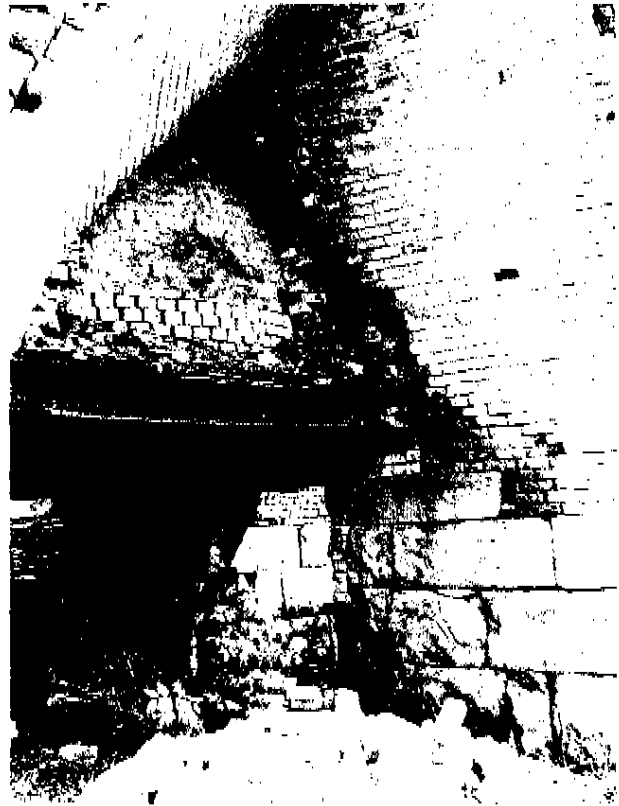
**Illustration 6: Casting arch c. 1935 (above)
Casting arch 2004 (below)**
